# The application of nitrogen to control a spontaneous combustion event during a longwall face salvage

**ABSTRACT:** In the UK, powered supports are normally salvaged from longwall faces on completion of production, for reuse on the next unit. Where a spare set of supports are held, the salvaged supports are often stored in underground roadways awaiting installation. One mine in the UK extracts a 5m section, and holds two sets of 2x950t powered supports, each weighing approx. 35t and having closed dimensions of 8m long, 2.5 high and 1.75m wide. As the first set would not be required for over 12 months, and because of space limitations below ground, it was decided that the supports would be left in situ, the district sealed, and reopened at a later date for support salvage. The paper described the decision making process, and the inertisation of the sealed district utilising nitrogen generated on the mine surface and piped to the point of use. The re-entry and re-ventilation of the district are also described. The paper then goes on to describe in more detail the discovery of a spontaneous combustion event that occurred in the waste behind the powered supports, and its treatment an

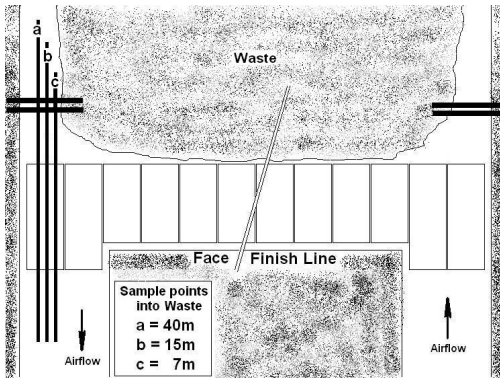
To help seal the waste at the tailgate end, a ventilation seal was constructed across the tailgate, immediately behind the return end of the face. This ventilation seal incorporated a deep waste sampling pipe which was extended the length of the tailgate and into the main return, thus allowing samples to be collected from this point either by the Tube Bundle system or by traditional hand sampling methods. In addition, three pipes were left through this seal, to points 40, 15 and 7m into the waste for possible future sampling. One of these later proved invaluable. (Figure 1).

Figure 1. Face end seals and sample pipe configuration

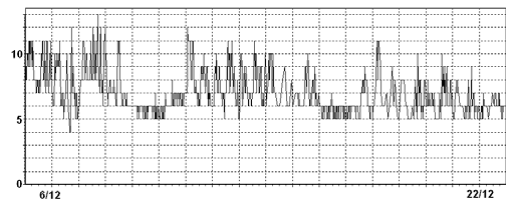
Salvage on the faceline commenced with the AFC working from the intake gate end up the face. By December 2006 all the AFC had been removed work was concentrating on commissioning of the Petito Mule, to be used on the face line for pulling the PRS out of rank, and the Eimco 942 transporters which would be used to remove them from the district. Work was suspended over the Christmas period. From the initial re-entry right up to this point environmental results continued to show that there was no spontaneous combustion activity: Figure 2 showing between 7 and 9 ppm generally during the early part of December 2006.

Figure 2. District CO level 5<sup>th</sup> December to 22<sup>nd</sup> December 2006.

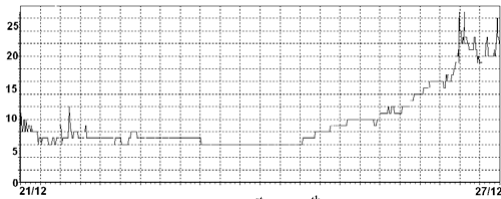
On the morning of Christmas Eve, CO levels were at their normal level of 6/7 ppm. However CO levels on the district started to rise and by noon on Christmas Day the CO level at the outbye end of the tailgate was 10ppm, and by midnight 14ppm. On Boxing Day morning the inspecting official identified what he thought was the source of an incipient heating with an increased CO pick up in the roof at around 150 PRS. This CO rise is shown by figure 3.

Figure 3. District CO level 21<sup>st</sup> to 27<sup>th</sup> December 2006

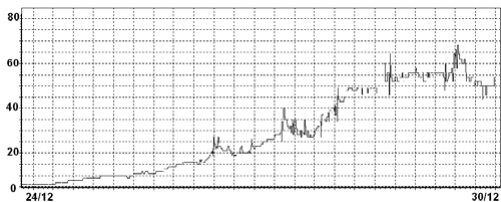
Interpretation of the analysis was complicated by the fluctuating presence of waste gas and the possibility that injected nitrogen had reached the sample point. However it was believed that at this stage of the incident nitrogen injection rates were not of sufficient volume to drive nitrogen to the sample point. Figure 4 shows the CO concentration in the tailgate during this period.

Figure 4. District CO levels from 24<sup>th</sup> to 30<sup>th</sup> December 2006.

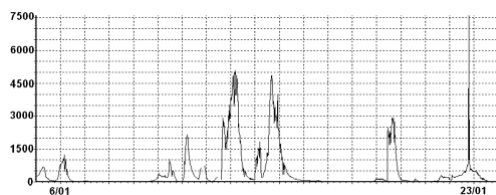
Monitoring the beneficial effects of the above remedial measures by analysis of the combustion products was complicated by the effects of the barometric pressure which fluctuated widely and sometimes rapidly during the whole incident. This had the effect of drawing waste gas towards, and at other times away from, the sample pipes and either contaminating or diluting the control analysis from these sample pipes. The effect can clearly be seen on Figures 5 to 8, which show that CO, CH<sub>4</sub> and O<sub>2</sub> all varied in line with the barometer, either directly or inversely. A clear understanding of the effects of changing barometric pressure on the control analysis was established and used to inform decision making to avoid erroneous conclusions being drawn from the control analysis.

Figure 5. CO level from Sample Pipe B under varying Barometric pressures.

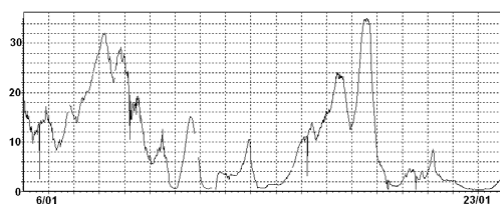
Figure 6. Methane level from Sample Pipe B under varying Barometric pressures.

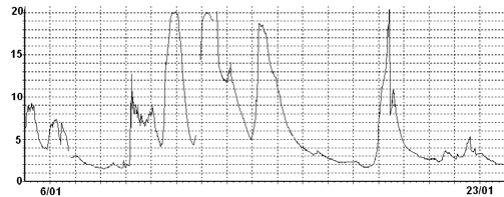
Figure 7. Oxygen level from Sample Pipe B under varying Barometric pressures.

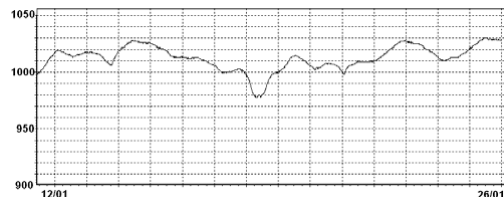
Figure 8. Variation in Barometric Pressure over the sampled period.

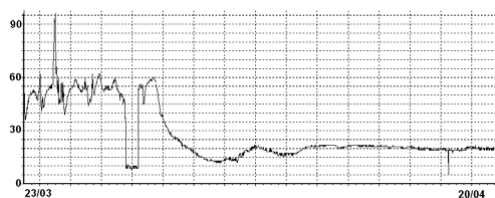
Figure 9. CO at sample point B during sealing / inertisation.

All the powered roof supports were salvaged by the 23rd March and the district was finally sealed by 5m explosion proof stoppings. Inertisation was achieved by the 29th March 2007. (Figure 9).
